# Quality Assessment of Five Randomly Chosen Ceramic Oral Implant Systems: Cleanliness, Surface Topography, and Clinical Documentation

Dirk U. Duddeck, DDS<sup>1</sup>/Tomas Albrektsson, MD, PhD, ODhc<sup>2,4</sup>/Ann Wennerberg, DDS, PhD<sup>3</sup>/  
Christel Larsson, DDS, PhD<sup>4</sup>/Jaafar Mouhyi, DDS, PhD<sup>5</sup>/Florian Beuer, DDS, PhD, MME<sup>1</sup>

**Purpose:** After some initial setbacks in the 1970s, ceramic implants seem to be a promising alternative to titanium implants. Since the surface of an implant system represents the interface to surrounding biologic structures, the study focuses on cleanliness and surface topography. Clinical documentation of the corresponding systems completes the picture and allows a better evaluation of zirconia implant systems. **Materials and Methods:** Five different ceramic implant systems were selected randomly and purchased via blind-shopping: Z5s (Z-Systems), Zibone (COHO), W implant (TAVDental), ceramic implant (vitaclinical), and BioWin!/Standard Zirkon Implantat (Champions-Implants/ZV3 system). Three samples of each implant system underwent scanning electron microscopy (SEM) imaging and elemental analysis (EDS). Where

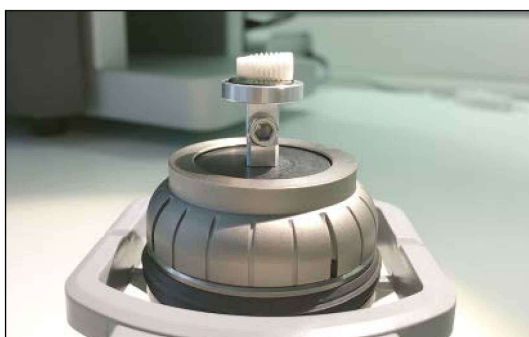
**Fig 1** Implant sample mounted on SEM sample holder in cleanroom environment.

Three samples of each implant type were carefully unpacked, mounted on the sample holder of a scanning electron microscope (SEM) without touching the implant surface, and subsequently analyzed in the SEM. In order to avoid any artifacts from the ambient air, the sample preparation and the scanning process were carried out in a particle-free cleanroom environment (according to Class 100 US Federal Standard 209E, Class 5 DIN EN ISO 14644-1; Fig 1).

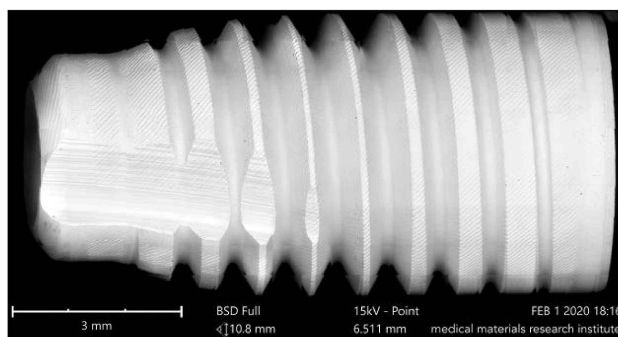
**Fig 2** Digitally composed SEM mapping image, Z5s implant (Z-Systems). Backscattered electrons (BSE) illustrate possible differences in the chemical composition of the sample.

Prior to the detailed analysis of potential impurities, up to 600 single high-resolution SEM images of each implant in 500× magnification were digitally composed in the "Image-Mapping" mode into one large SEM image, showing the full size of the implant from shoulder to apex at a viewing angle of approximately 120 degrees (Fig 2).

**Z-Systems, Z5s Implant.** The analyzed implant samples (expiration dates: October 2022 and December 2022) showed less than 10 organic particles (10 to 30  $\mu$ m; Figs 2 and 3a to 3c). The implant surface displayed aluminum oxide particles, probably as part of the production process. None of the three analyzed implant samples showed systematic contamination. No pattern for the distribution of particles was found.

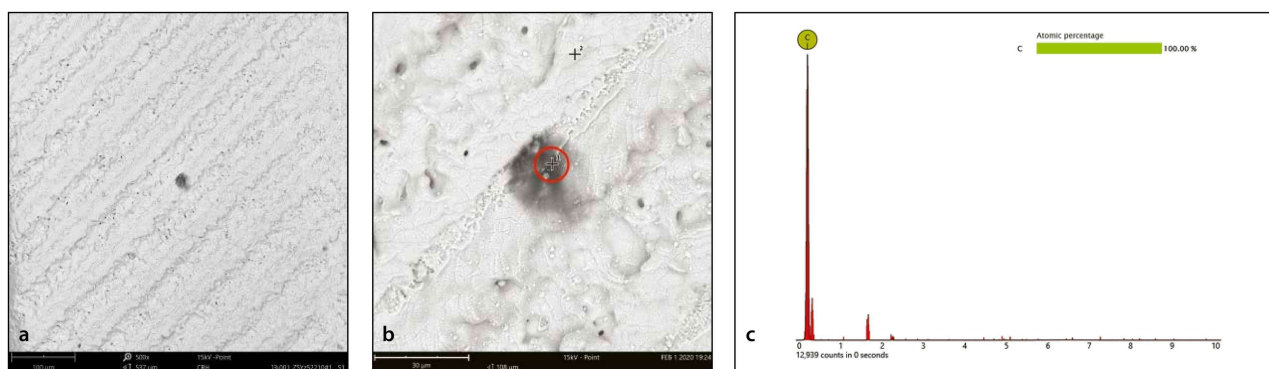
**Fig 3** SEM/EDS analysis of the Z5s Implant (Z-Systems). (a) SEM 500 $\times$ , (b) SEM 2,500 $\times$  with marked spots for EDS analysis, (c) differential EDS spot measurement (#1 minus #2); quantitative and qualitative elemental analysis of an organic particle (20 to 30  $\mu$ m).

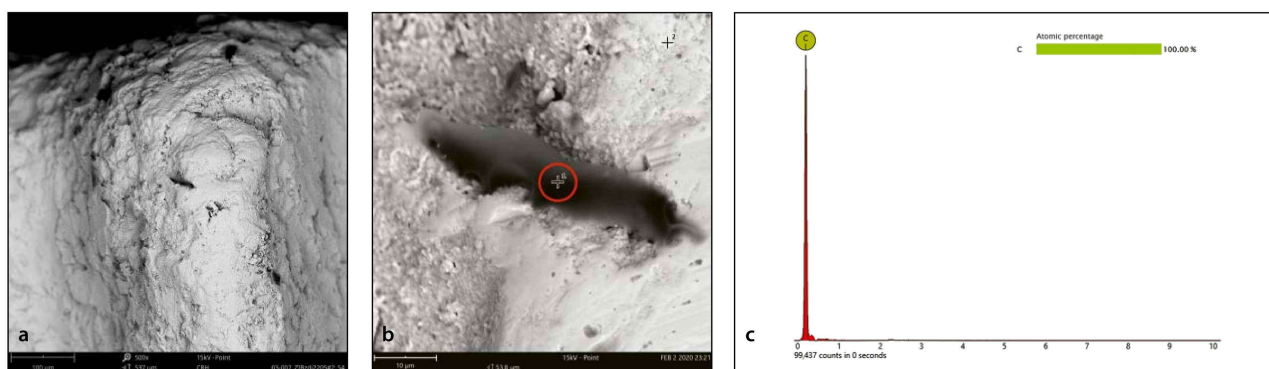
**Fig 4** SEM/EDS analysis of the Zibone Implant (COHO Biomedical Technology). (a) SEM 500x, (b) SEM 5,000x with marked spots for EDS analysis, (c) differential EDS spot measurement (#1 minus #2); quantitative and qualitative elemental analysis revealed organic nature of the particle.

**COHO Biomedical Technology, Zibone.** The three samples of Zibone’s ceramic implant showed a mixed picture (all samples’ expiration date: May 2022). While one sample showed less than 10 organic particles with a diameter of 10 to 20  $\mu$ m, another sample from the same batch showed approximately 50 organic particles (5 to 40  $\mu$ m), especially on the outer thread flanks near the apex of the implant (Figs 4a to 4c).

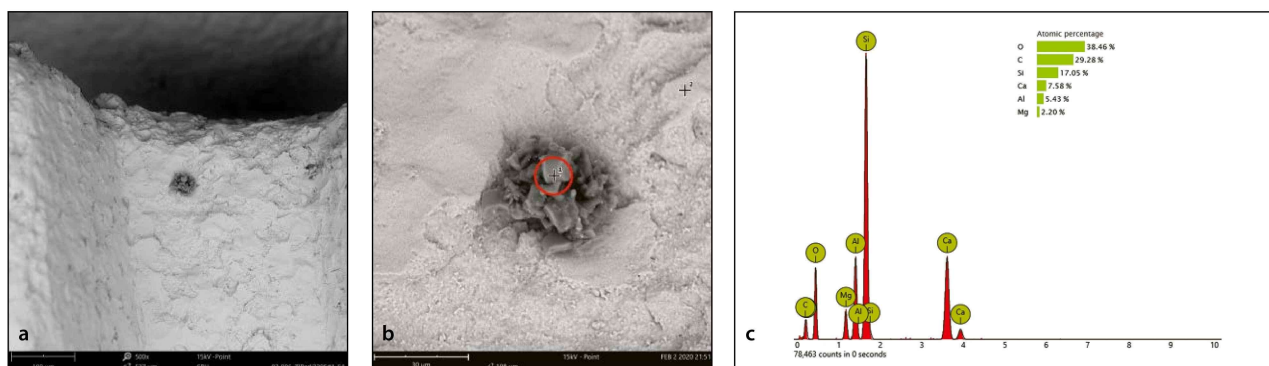
**Fig 5** SEM/EDS analysis of the Zibone Implant (COHO Biomedical Technology). (a) SEM 500x, (b) SEM 2,500x with marked spots for EDS analysis, (c) differential EDS spot measurement (#1 minus #2); quantitative and qualitative elemental analysis showed different elements of the compound.

The third sample presented the same number of organic particles with no pattern of distribution. In addition to this, one sample showed particle conglomerates (20 to 30  $\mu$ m) with significant amounts of silicon, magnesium, calcium, and aluminum (Figs 5a to 5c). Subsequent ToF-SIMS analysis of a sterile packaged sample detected talc, DBSA, and fatty acid ester (results not shown).

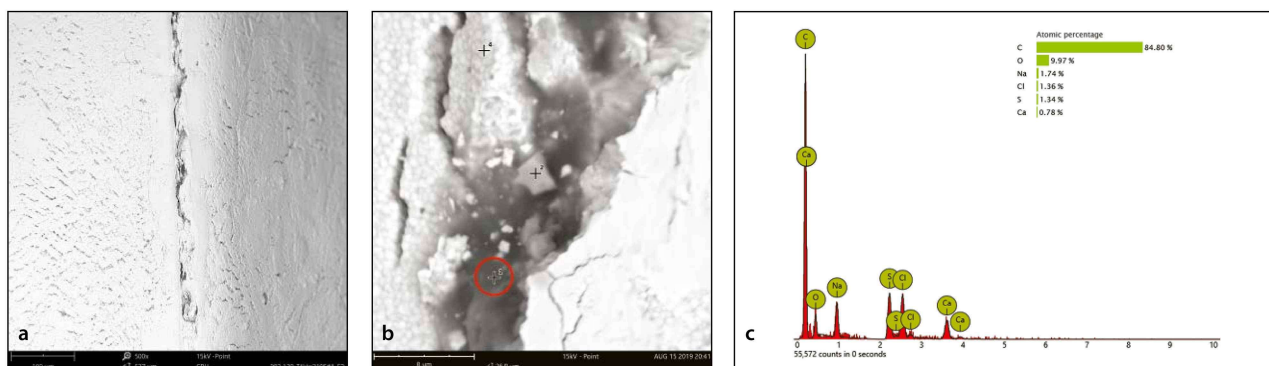
**Fig 6** SEM/EDS analysis of the W Implant (TAV Dental). (a) SEM 500x, (b) SEM 10,000x with systematic organic contamination in a long material crack (> 500  $\mu$ m) on the implant shoulder, (c) differential EDS spot measurement (#1 minus #4). This organic impurity revealed mainly carbon and small amounts of oxygen, sodium, chlorine, sulfur, and calcium in the elemental analysis. (The embedded grey particle #2 showed signals of aluminum oxide.)

**TAV Dental, W implant.** The analyzed implant samples (expiration dates: May 2021 and June 2024) presented a very mixed picture. The first sample showed remarkable organic impurities (5 to 80  $\mu$ m), especially at the implant shoulder and distributed over the entire implant (Figs 6a to 6c). One particle (10 to 15  $\mu$ m) showed additional traces of magnesium, sulfur, sodium, and chlorine, while another particle (3 to 5  $\mu$ m) contained traces of titanium and aluminum; one particle

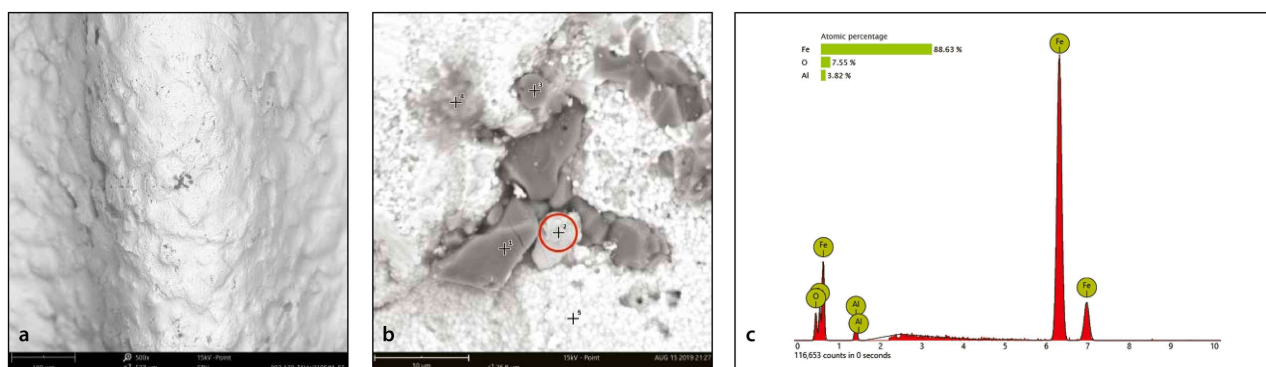
**Fig 7** SEM/EDS analysis of the W Implant (TAV Dental). (a) SEM 500 $\times$ , (b) SEM 7,500 $\times$  with marked spots for EDS analysis, (c) differential EDS spot measurement (#2 minus #5). Quantitative and qualitative elemental analysis of the particle (3 to 5  $\mu$ m) showed iron, aluminum, and oxygen. (#1 and #3 are most likely remnants of aluminum oxide particles; #4 is of organic nature.)

contamination (4 to 6  $\mu$ m) indicated significant traces of iron in the elemental analysis (Figs 7a to 7c). While the first sample presented significant organic contamination, the second implant showed less particulate contamination of organic nature. Instead, several apparently melted impurities (20 to 60  $\mu$ m) were found with clear traces of silicon, oxygen, sodium, and aluminum (possibly aluminum sodium silicates; Figs 8a to 8c). The same components were detected in an impurity of

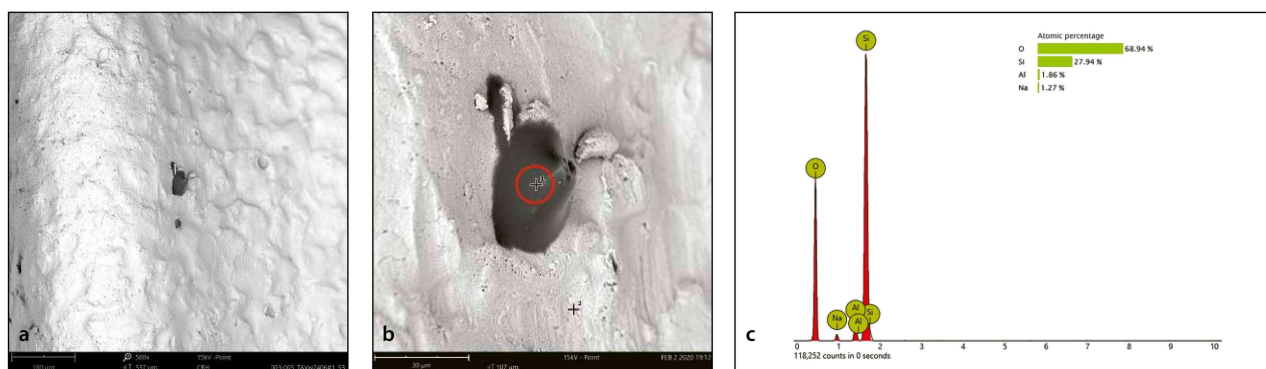
**Fig 8** SEM/EDS analysis of the W Implant (TAV Dental). (a) SEM 500 $\times$ , (b) SEM 2,500 $\times$  with marked spots for EDS analysis, (c) differential EDS spot measurement (#1 minus #2); quantitative and qualitative elemental analysis of the particle (30 to 60  $\mu$ m) showed signals of silicon, oxygen, aluminum, and sodium.

the third sample (10 to 50  $\mu$ m). In addition, this sample showed a solid metal particle of 20 to 40  $\mu$ m with iron, silicon, aluminum, magnesium, and potassium in the elemental analysis. External implant threads showed small aluminum oxide particles (2 to 5  $\mu$ m) as an accumulation in an area of 20 to 30  $\mu$ m in diameter. In the ToF-SIMS analysis of a sterile packaged implant sample from the same type, point-accumulations of aliphatic hydrocarbon compounds were noticeable (results not shown here).

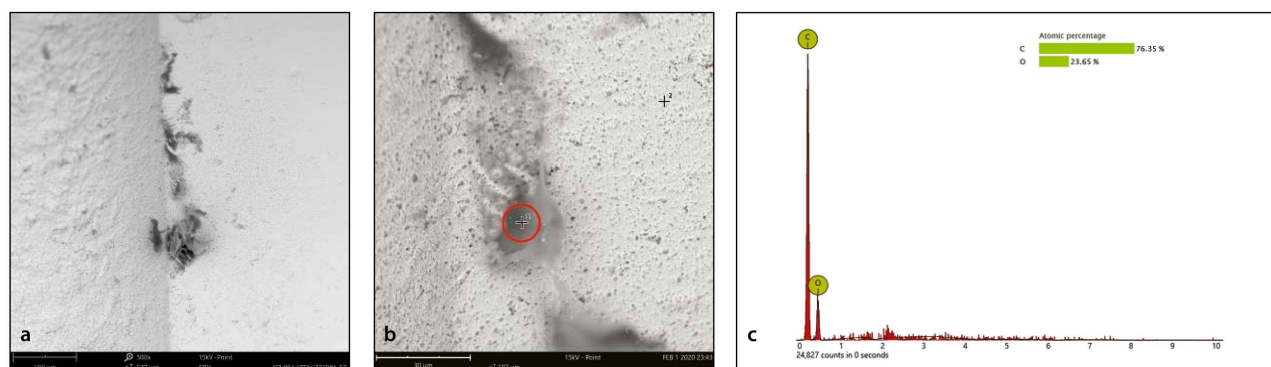
**Fig 9** SEM/EDS analysis of the ceramic implant (vitaclinical). (a) SEM 500 $\times$ , (b) SEM 2,500 $\times$  with marked spots for EDS analysis, (c) differential EDS spot measurement (#1 minus #2); quantitative and qualitative elemental analysis of a real contamination (particle sizes 10 to 100  $\mu$ m) on the first implant thread showed signals of carbon and oxygen.

**vitaclinical, ceramic.Implant.** All three samples (expiration dates: July 2020, October 2020, and October 2023) showed a pattern of organic contamination, where major areas with a length of up to 1.0 mm at the implant shoulder and the first implant thread were covered with numerous organic particles (Figs 9a to 9c). In addition, more than 50 organic particles with a variation of 10  $\mu$ m to 1 mm in diameter were found on the implant surface of all samples in random distribution. The elemental analysis of one mainly organic particle (10 to 15  $\mu$ m) on sample #1 revealed significant signals of iron and minor traces of chromium, potassium, chlorine, and sulfur (Figs 10a to 10c).

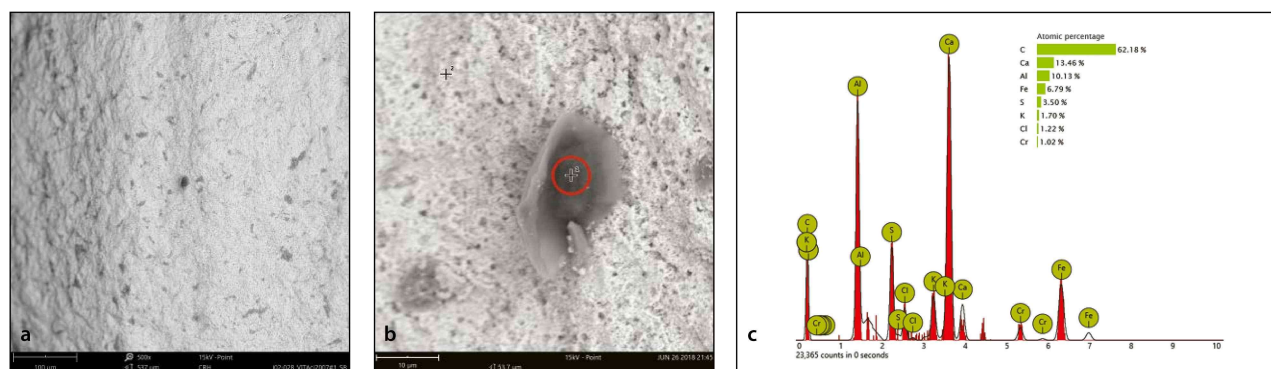
**Fig 10** SEM/EDS analysis of the ceramic implant (vitaclinical). (a) SEM 500 $\times$ , (b) SEM 5,000 $\times$  with marked spots for EDS analysis, (c) differential EDS spot measurement (#1 minus #2); quantitative and qualitative elemental analysis of single particle (10 to 20  $\mu$ m) showed interalial signals of different metals.

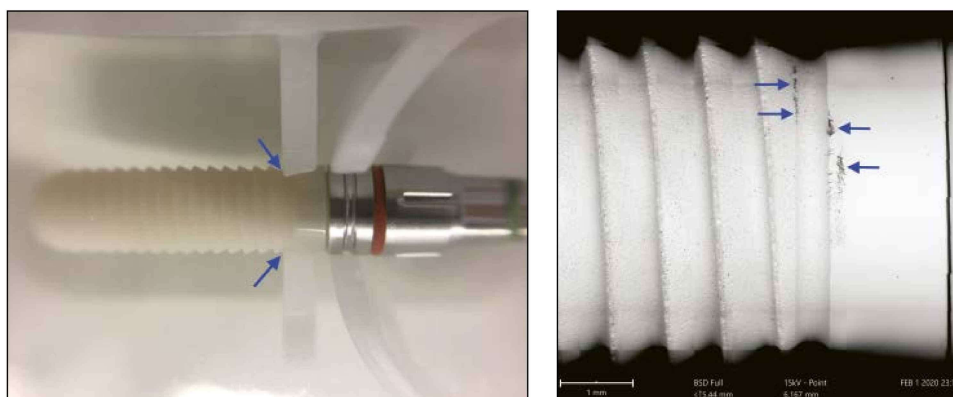
**Fig 11** (Left) Photographic image of the ceramic implant fixation inside the packaging (vitaclinical).

**Fig 12** (Right) SEM mapping image of the same implant. Material contrast shows traces of foreign material (dark particles, allocated in a range of 1 to 1.5 mm) on the implant shoulder and the first implant thread.

As photographic images of the implant packaging indicate, one reason for the massive organic

contamination at the implant shoulder and the first thread of all samples of this implant type can be the packaging itself (Figs 11 and 12).

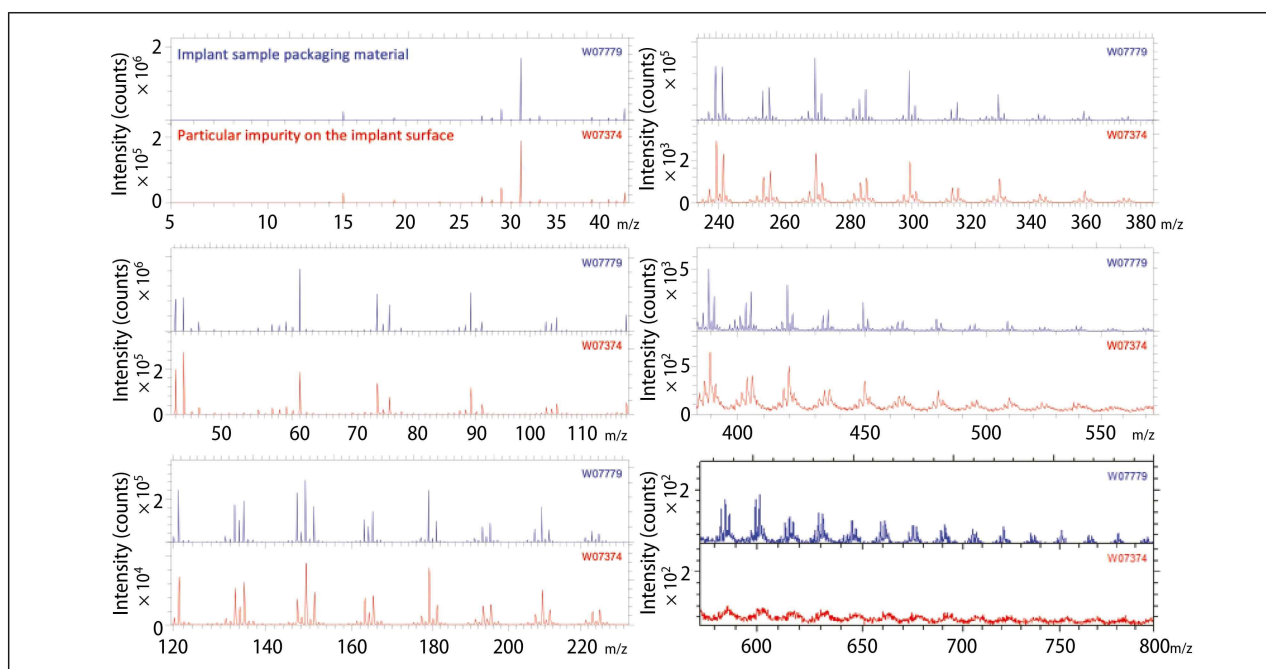
**Fig 13** Comparison of ToF-SIMS spectra (blue = packaging material as seen in Fig 11, red = impurity on the implant surface as seen in Fig 12), primary ion Bi<sup>3+</sup>, 30 keV; both materials are chemically identical and consist of polyacetal (extract from test report A28710b, with permission of Tascon).

Two sterile packaged samples of the same implant type were examined (expiration dates: October 2020 and October 2023) by ToF-SIMS. As in the correspondent SEM imaging, one sample showed significant contamination in the area of the first implant thread. The plastic packaging material in contact with the implant surface was subjected to the same analysis. The matching of data with reference-spectra showed that both packaging and contamination consist of polyacetal, also known as polyoxymethylene (POM), which is an engineering thermoplastic (Fig 13). From this result and the position of the contamination on the threads, it can be concluded that a mechanical transfer of packaging material to the implant surface occurred.

Another organic residue on the implant surface of the second sample turned out to be polysiloxane. The analysis indicated additional residues of dodecylbenzene sulfonic acid (DBSA) and erucamide ( $C_{22}H_{43}NO$ ). DBSA is a surfactant and is used, inter alia, as a component in detergents,<sup>22</sup> while erucamide is used, inter alia, as an anti-adhesive agent for plastics.<sup>23</sup>

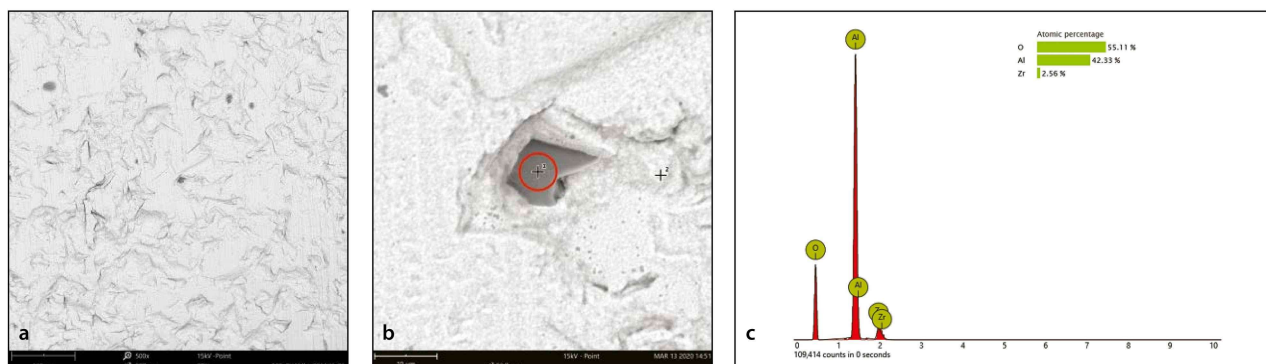
**Fig 14** SEM/EDS analysis of the BioWin!/Standard Zirkon Implantat (Champions-Implants/ZV3). (a) SEM 500x, (b) SEM 5,000x with marked spots for EDS analysis; (c) differential EDS spot measurement of a single particle (5 to 10 µm) showed signals of aluminum and oxygen.

**Champions-Implants, BioWin! (ZV3, Standard Zirkon Implantat).** The analyzed samples of the BioWin! (ZV3) implant (expiration dates: July 2022, August 2022, and November 2022) showed only particles of aluminum oxide (10 to 30  $\mu$ m). Within the scope of this analysis, organic impurities could not be detected (Figs 14a to 14c and 15).

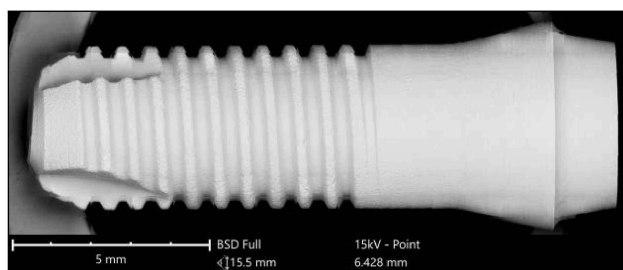
**Fig 15** SEM mapping image of the BioWin!/standard zirconium implant (Champions-Implants/ZV3).
